# **HORSESHOE POND RESTORATION PROJECT WETLAND DELINEATION REPORT**

## **POINT REYES NATIONAL SEASHORE**

**Amy Parravano  
Wetland Biologist**

**Point Reyes National Seashore  
February 2002**

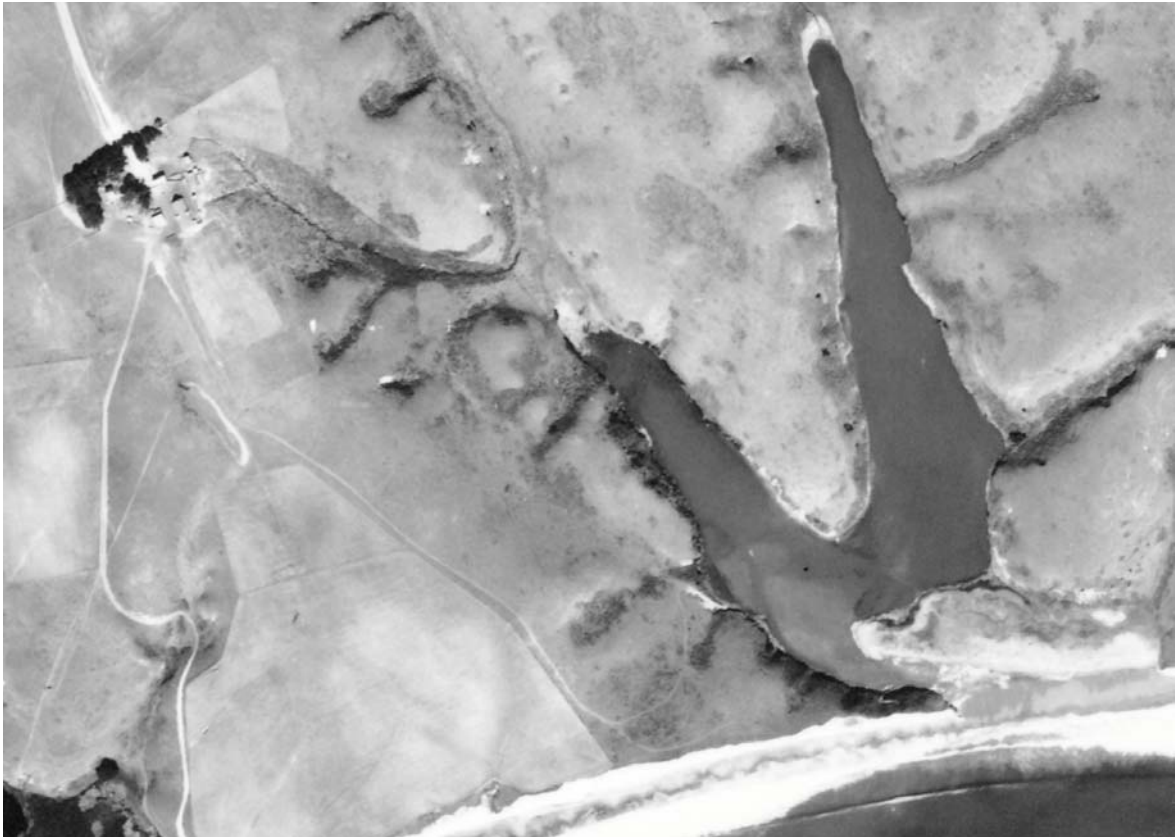
Figure 2. Aerial Photograph Illustrating Historic Outflow of Horseshoe Pond (PRNS Archives 1943)

Aerial photos from 1941 and 1943 reveal that the historic outflow of Horseshoe Pond existed in the southwest corner of the pond, opposite the current channel out onto Drakes' Beach (Figure 2). Visible in these photographs is a broad, sandy channel set against the west slope of the drainage. A large plume of sand is seen washed far into the pond from the channel. From these historic photos, the current channel on the west side of the pond appears to be dominated by exterior dune vegetation and interior wetland vegetation. The 1941 photograph, taken in December, shows a small pond set just behind the foredune.

Between 1943 and 1952, the Hall/Horick family built a road leading down from the ranch complex, across the front of Horseshoe Pond, and up a side drainage to the east pastures and a hunting cabin on the shore of Drakes' Estero. This construction project effectively cut off regular tidal exchange with Drakes' Bay. A bridge/culvert complex was developed to allow pond overflow onto the beach through the historic outflow channel, but the remainder of the historic channel was filled with material provided by a quarry set just west of the pond, along Drakes' Beach. Additional fill was laid along the entire dune barrier extending over to the east side of the pond.

By 1974, the pond had reached its current observed water levels and the historic channel had almost completely filled with vegetation, presumably the same composition of saltgrass (*Distichlis spicata*) and rushes (*Juncus* spp.) present today. At some point prior

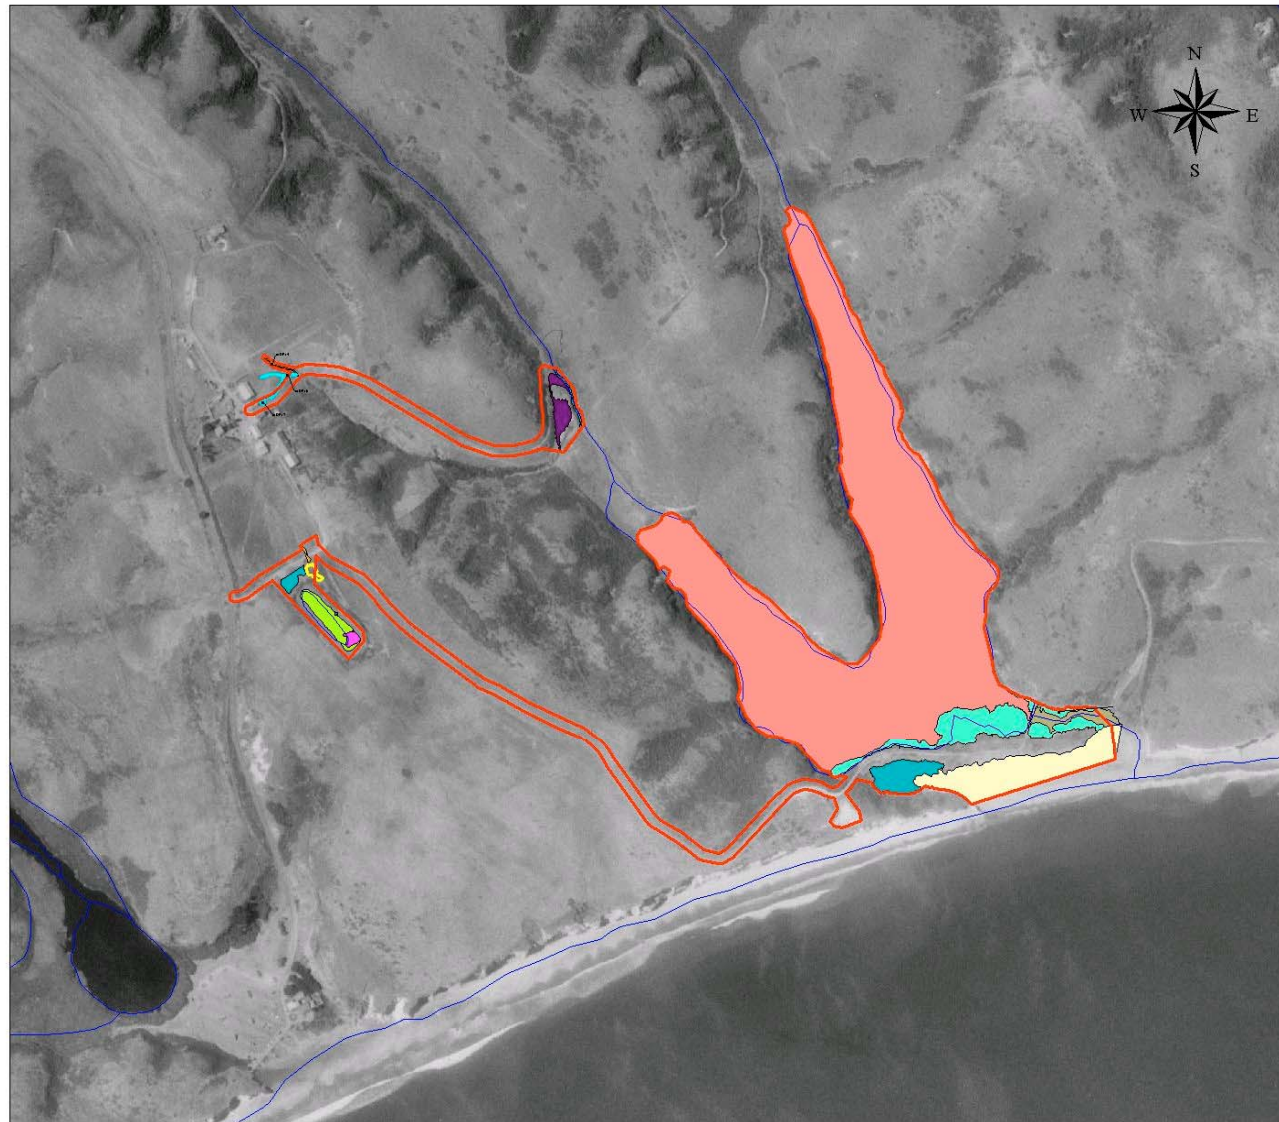
Figure 3. Map of all wetlands occurring within Horseshoe Pond Restoration Project Area

- Mit2\_area.shp
- Delineation Study Area
- Hydrography
- Cowardin Delineations**
- E1UBLh
- E2EMPh
- E2SBPh
- M2USP
- PEMA
- PEMB
- PEMBxh (considered for classification, but rejected)
- PEMC (considered for classification, but rejected)
- PEMCh (considered for classification, but rejected)
- PEMH
- PUBChx
- PUBFhx
- PUBHhx
- Cowardin Delineations**
- PEMA
- PEMH
